# Manhole Inspection Summary

Manhole # S02CC2018MH

Insp Date: **6/28/06 2:25 PM**

**Location** Address: **6700 CROSS COUNTRY BLVD**

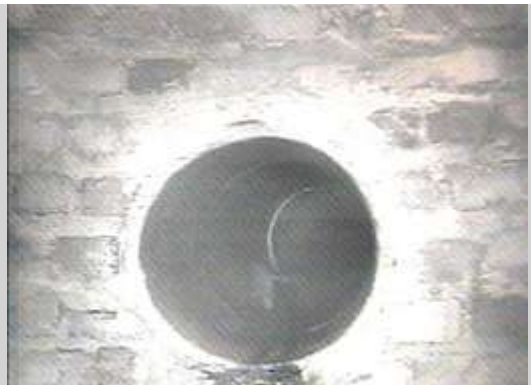
### 12 in. Circular Gravity Sewer Pipe In @ 6 O'Clock

Infiltration: **None** Pipe Seal Cond: **Unknown**

Drop Condition: **Partly Clogged**
